AGENDA  
MEETING OF THE DANGEROUS STRUCTURE DETERMINATION BOARD  
CITY OF LIVE OAK  
WILL BE HELD AT THE LIVE OAK COUNCIL CHAMBERS  
8001 SHIN OAK DRIVE  
THURSDAY, DECEMBER 4, 2025 AT 11:00 A.M.

# DANGEROUS STRUCTURE DETERMINATION BOARD AGENDA ITEM FORM

Discussion and consideration regarding 11917 Toepperwein Road (Lot 71, Block 59, Toepperwein Office Park) to determine (1) whether structure(s) meet the definition of a dangerous building to be considered a nuisance; and (2) if the structure(s) are dangerous and therefore a nuisance, what remediation may be required.

City staff has determined that a public nuisance exists and is requesting that the Board make a determination and take action regarding the buildings and structures located at 8020 Old Austin Road. The site contains two abandoned single family detached structures and two small accessory structures. The structure noted as “building one” above has been abandoned since 2021, while the structure noted as “building two” above has been abandoned since

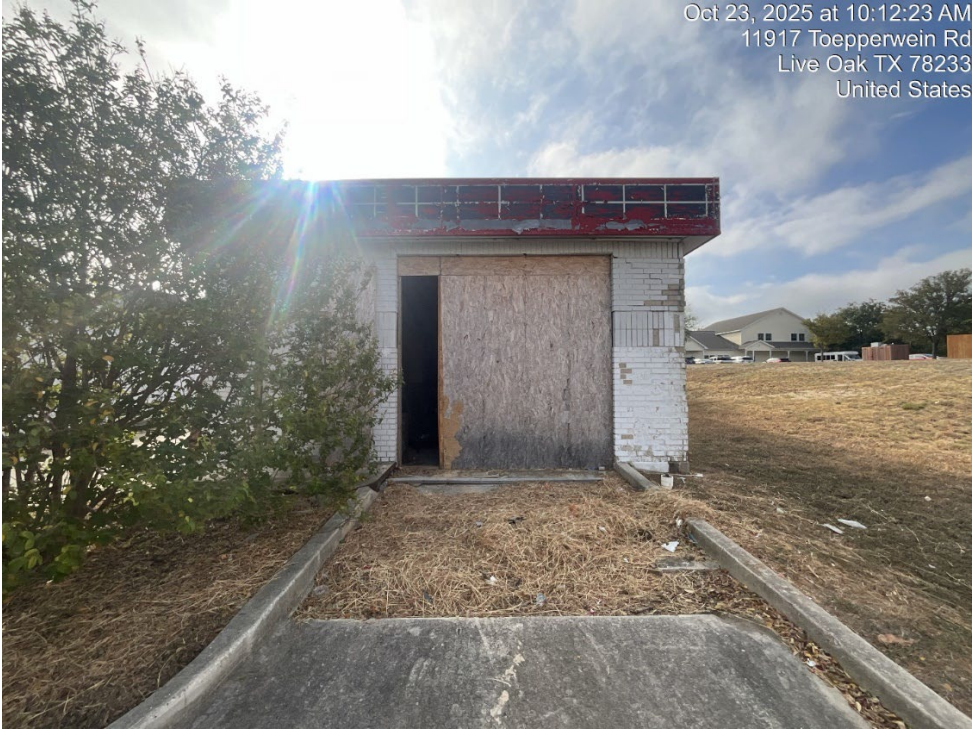
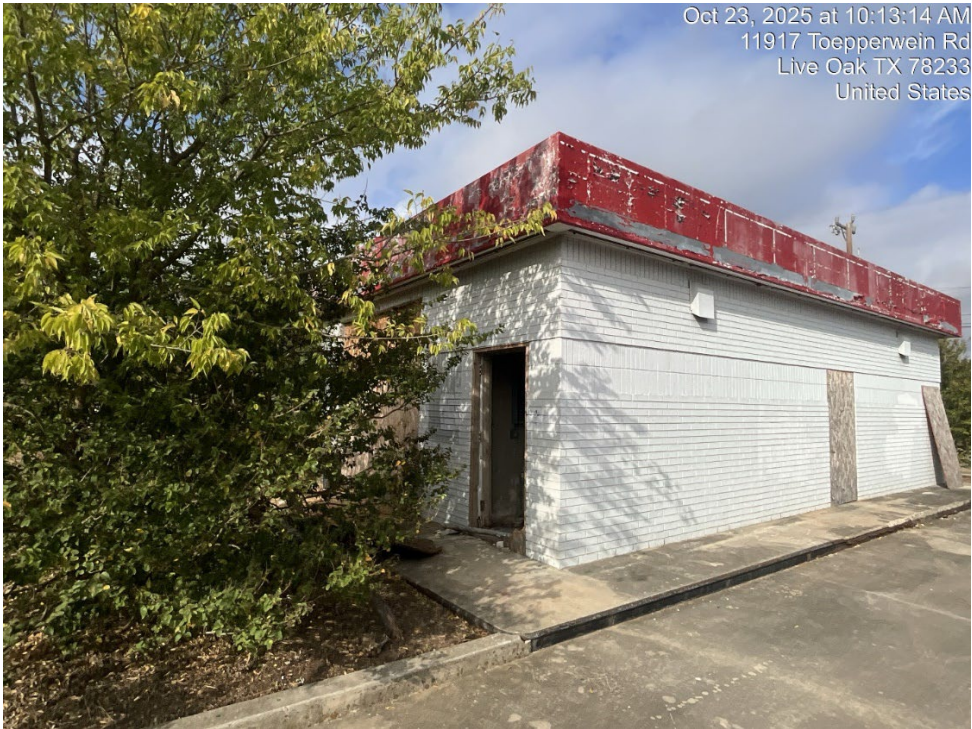
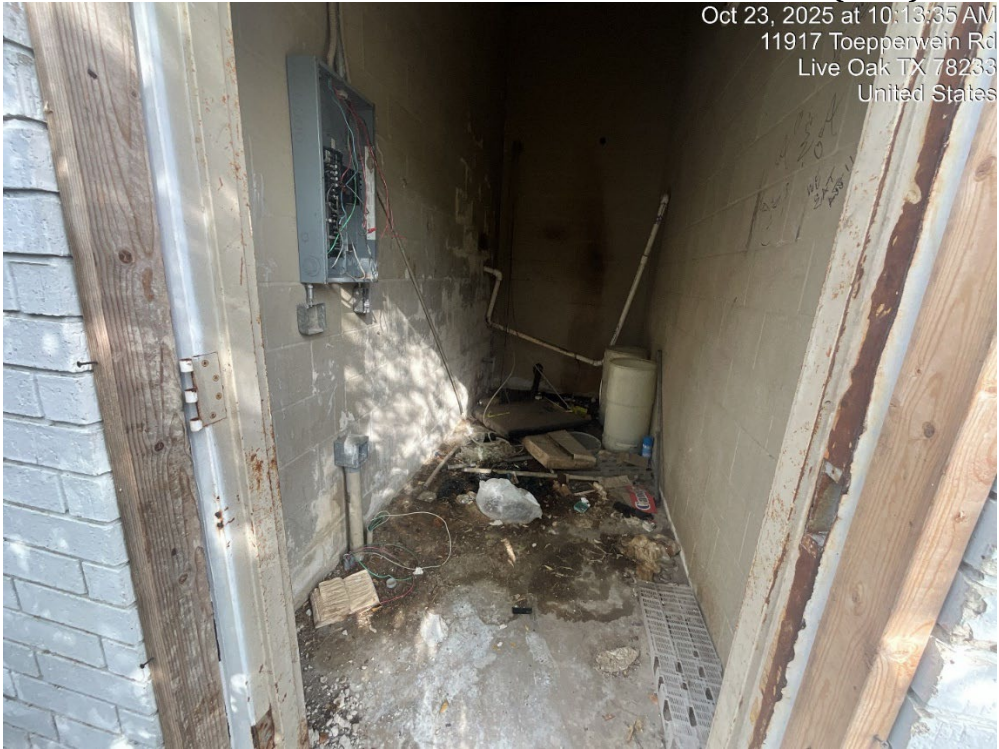
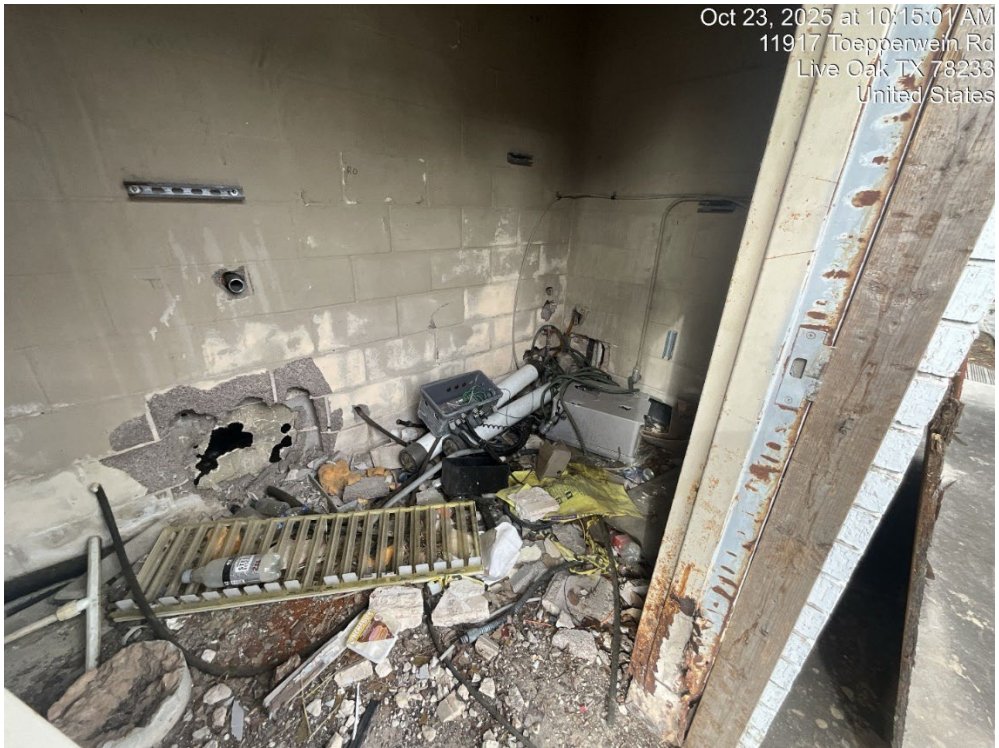
**SITE PICTURES – OCTOBER 2025 – CAR WASH BLDG:**

#### **Car Wash Building:**

- The interior contains junk, trash, and signs of vagrant activity.
- There are electrical conduits, housing and junction boxes with exposed wires.
- The entryway on the northside bay has a substantial crack in the top framing that may indicate some leveling issues.
- One of the plywood panels at the back door was damaged and ripped away from the frame.
- Plumbing inside is removed and/or exposed.
- Although the building was boarded up, there were a few small holes in the walls.

1. The property owner has up to 30 days from the date of the order to secure the building and structures and/or site such that potential building penetrations are minimized discouraging unauthorized entry;

2. The property owner has up to 30 days from the date of the order to provide a detailed scope and schedule to repair structural damages and/or further secure the site and structures as noted herein;

3. The property owner has up to 90 days from the date of the order to begin repairs of structural damages as noted herein, or demolish the buildings and structures;

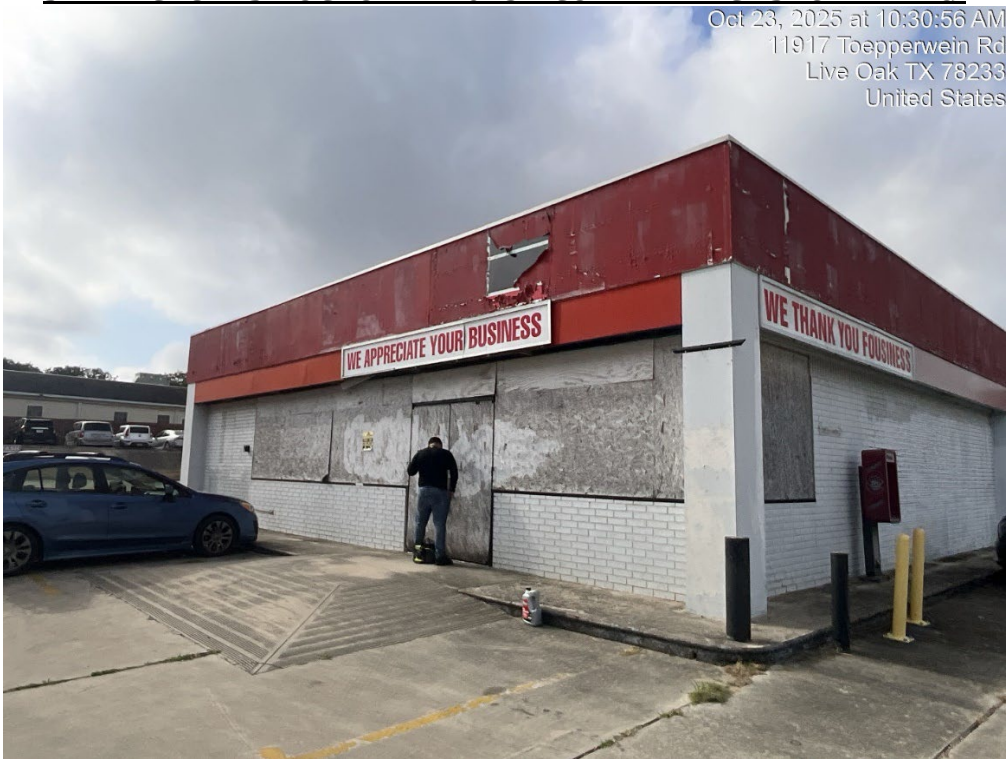
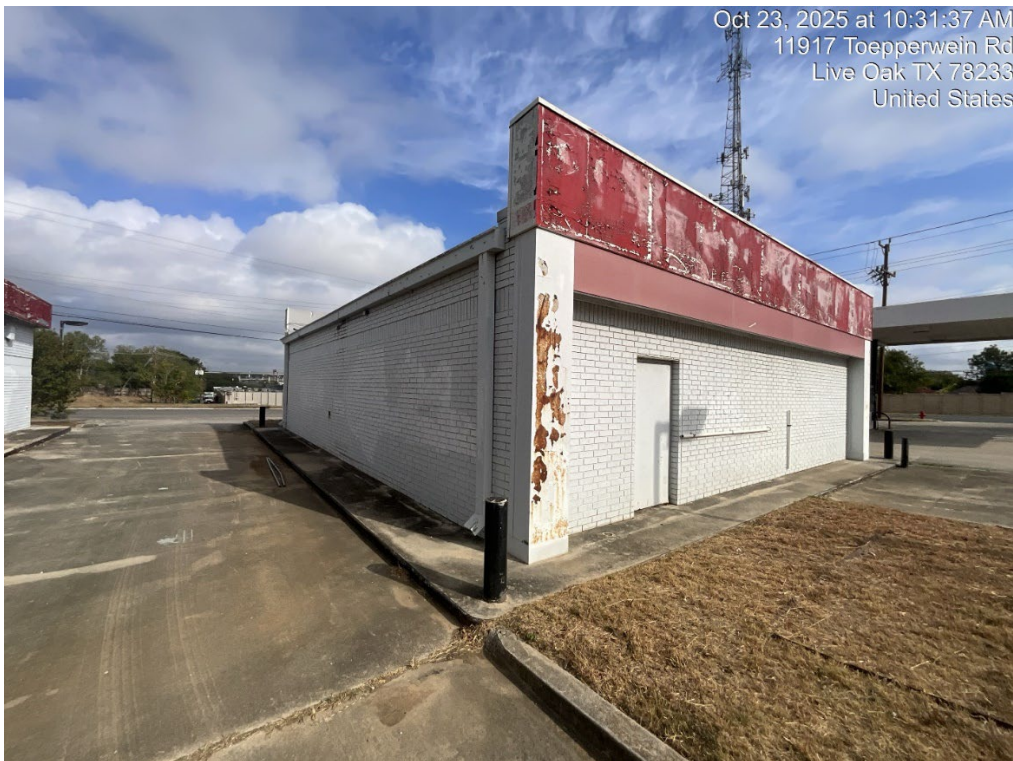
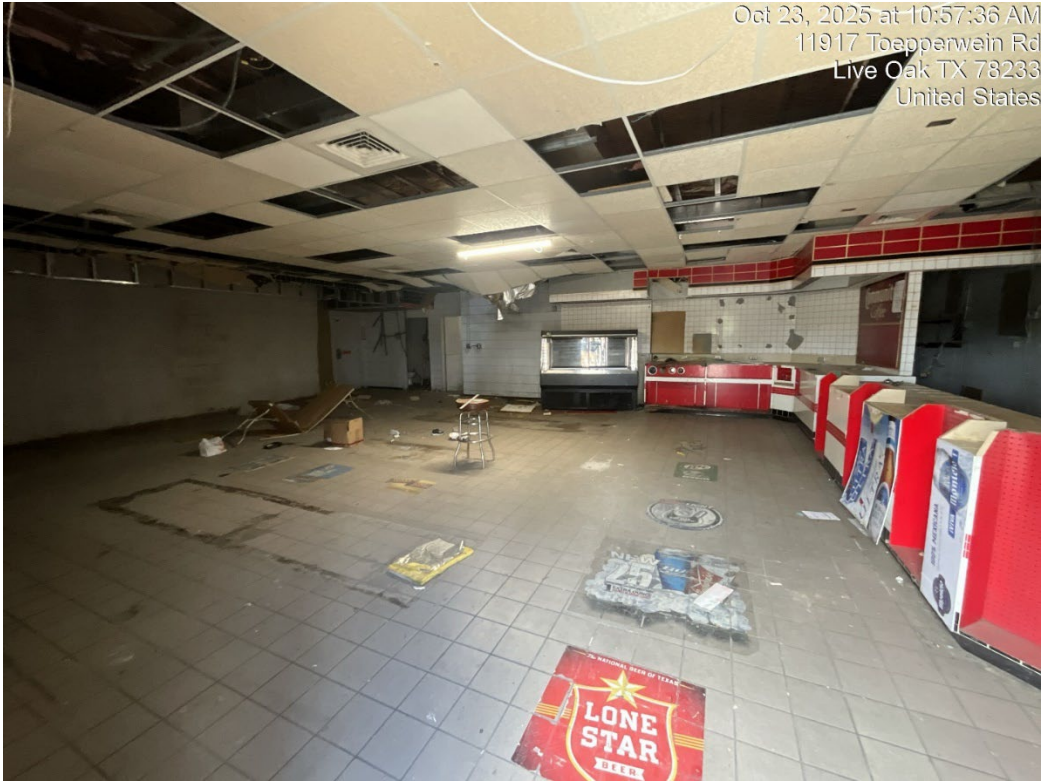
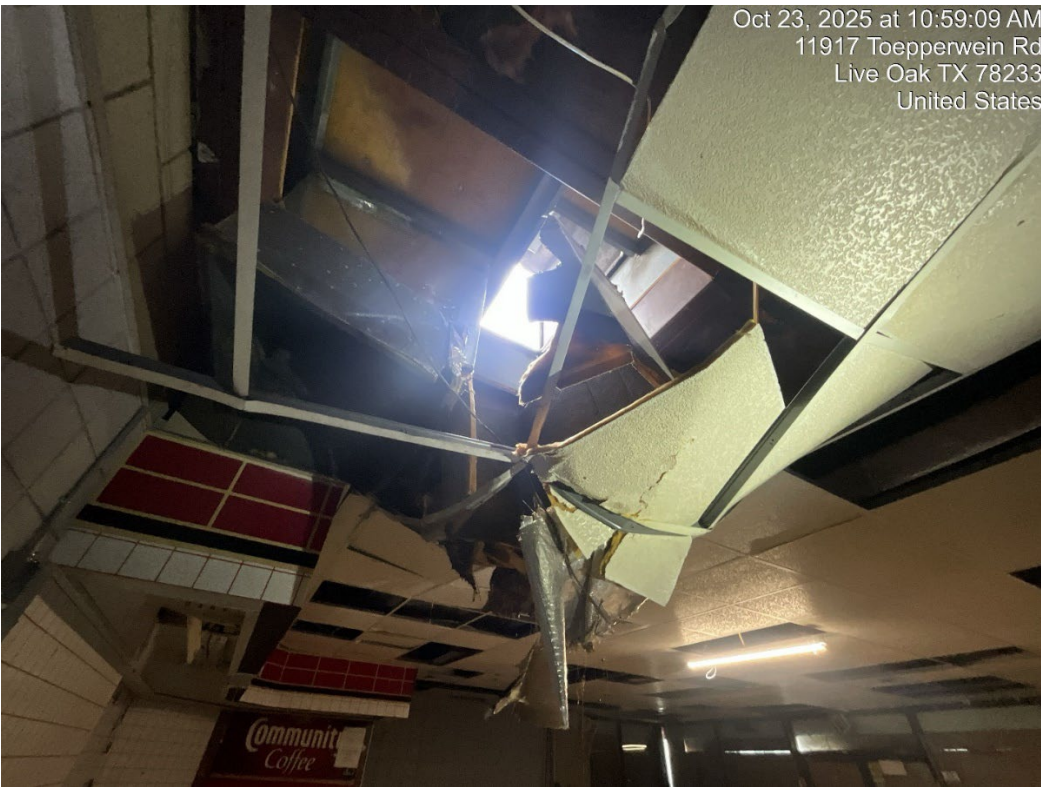
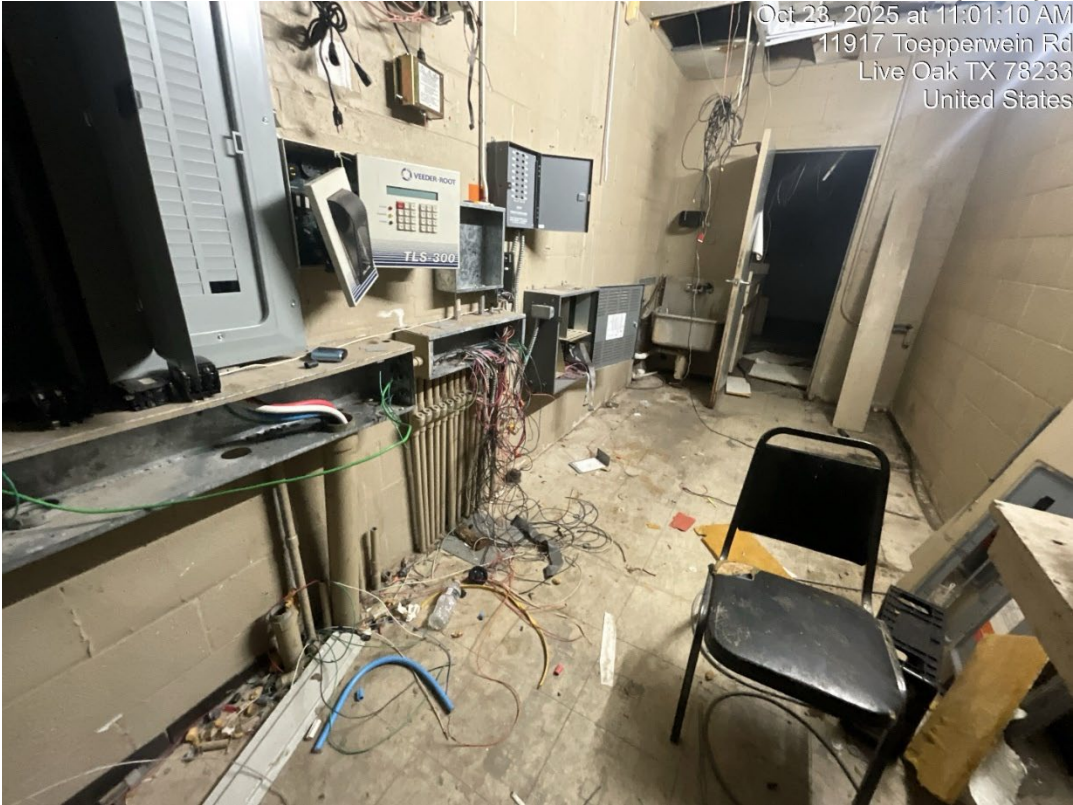
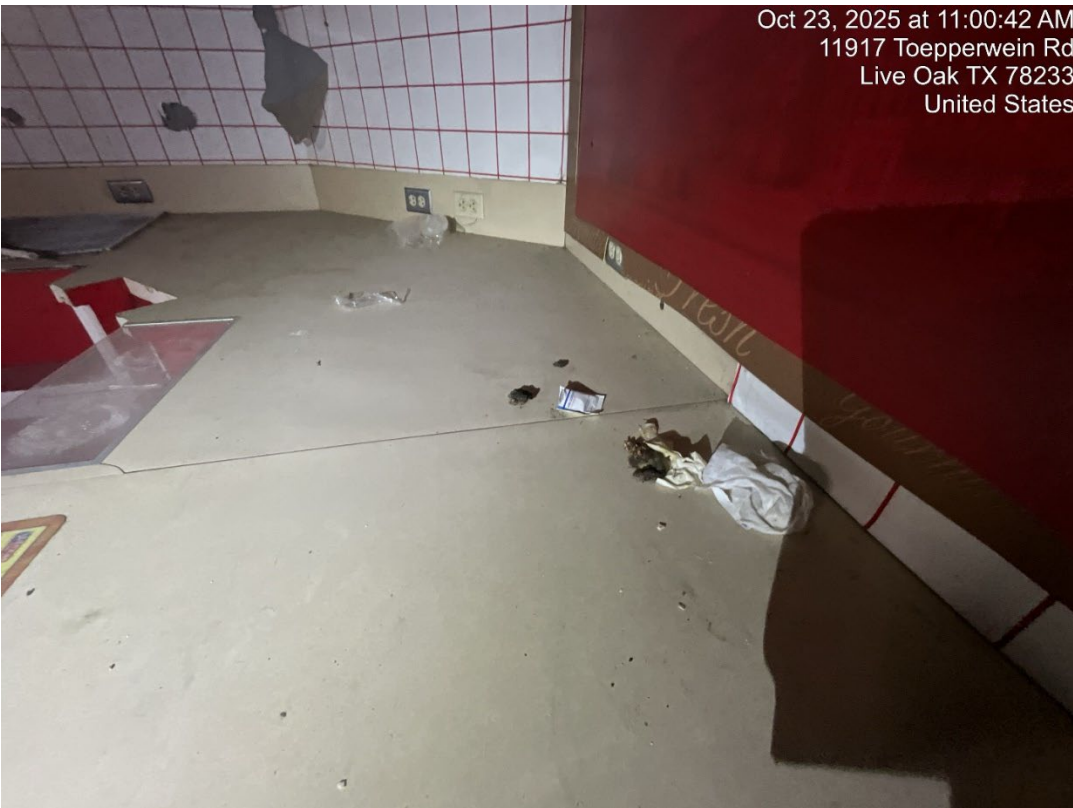
**SITE PICTURES – OCTOBER 2025 – CONVENIENCE STORE BLDG:**

#### **Convenience Store Building:**

- The building is not weather proofed and there is a large hole in the roof from a damaged Air Conditioning unit.
- There are signs of weather damage and as well as dry rot to the underlay that is evident around hole.

- There is a hole in the roof on the east side corner of the roof. There is water damaged and deterioration underlay.
- The back of the building located on the west side of the building has trash, and vandalized wires.

- The kitchen fixtures have been damaged or partially removed as well.
- There is active power to the building, however, no electricity source could be determined as there is no electric meter and electrical wiring in the building has sustained significant damage.

- There are signs of rodent infestation.
- Deterioration of the building façade canopy including structural detachment;
- Caulking is rotting off at masonry expansion joints on the exterior walls;

- There is a small wall penetration at the rear of the building, approximately 4 inches in diameter, which may allow rodents and other outside infiltration of pests into the building;

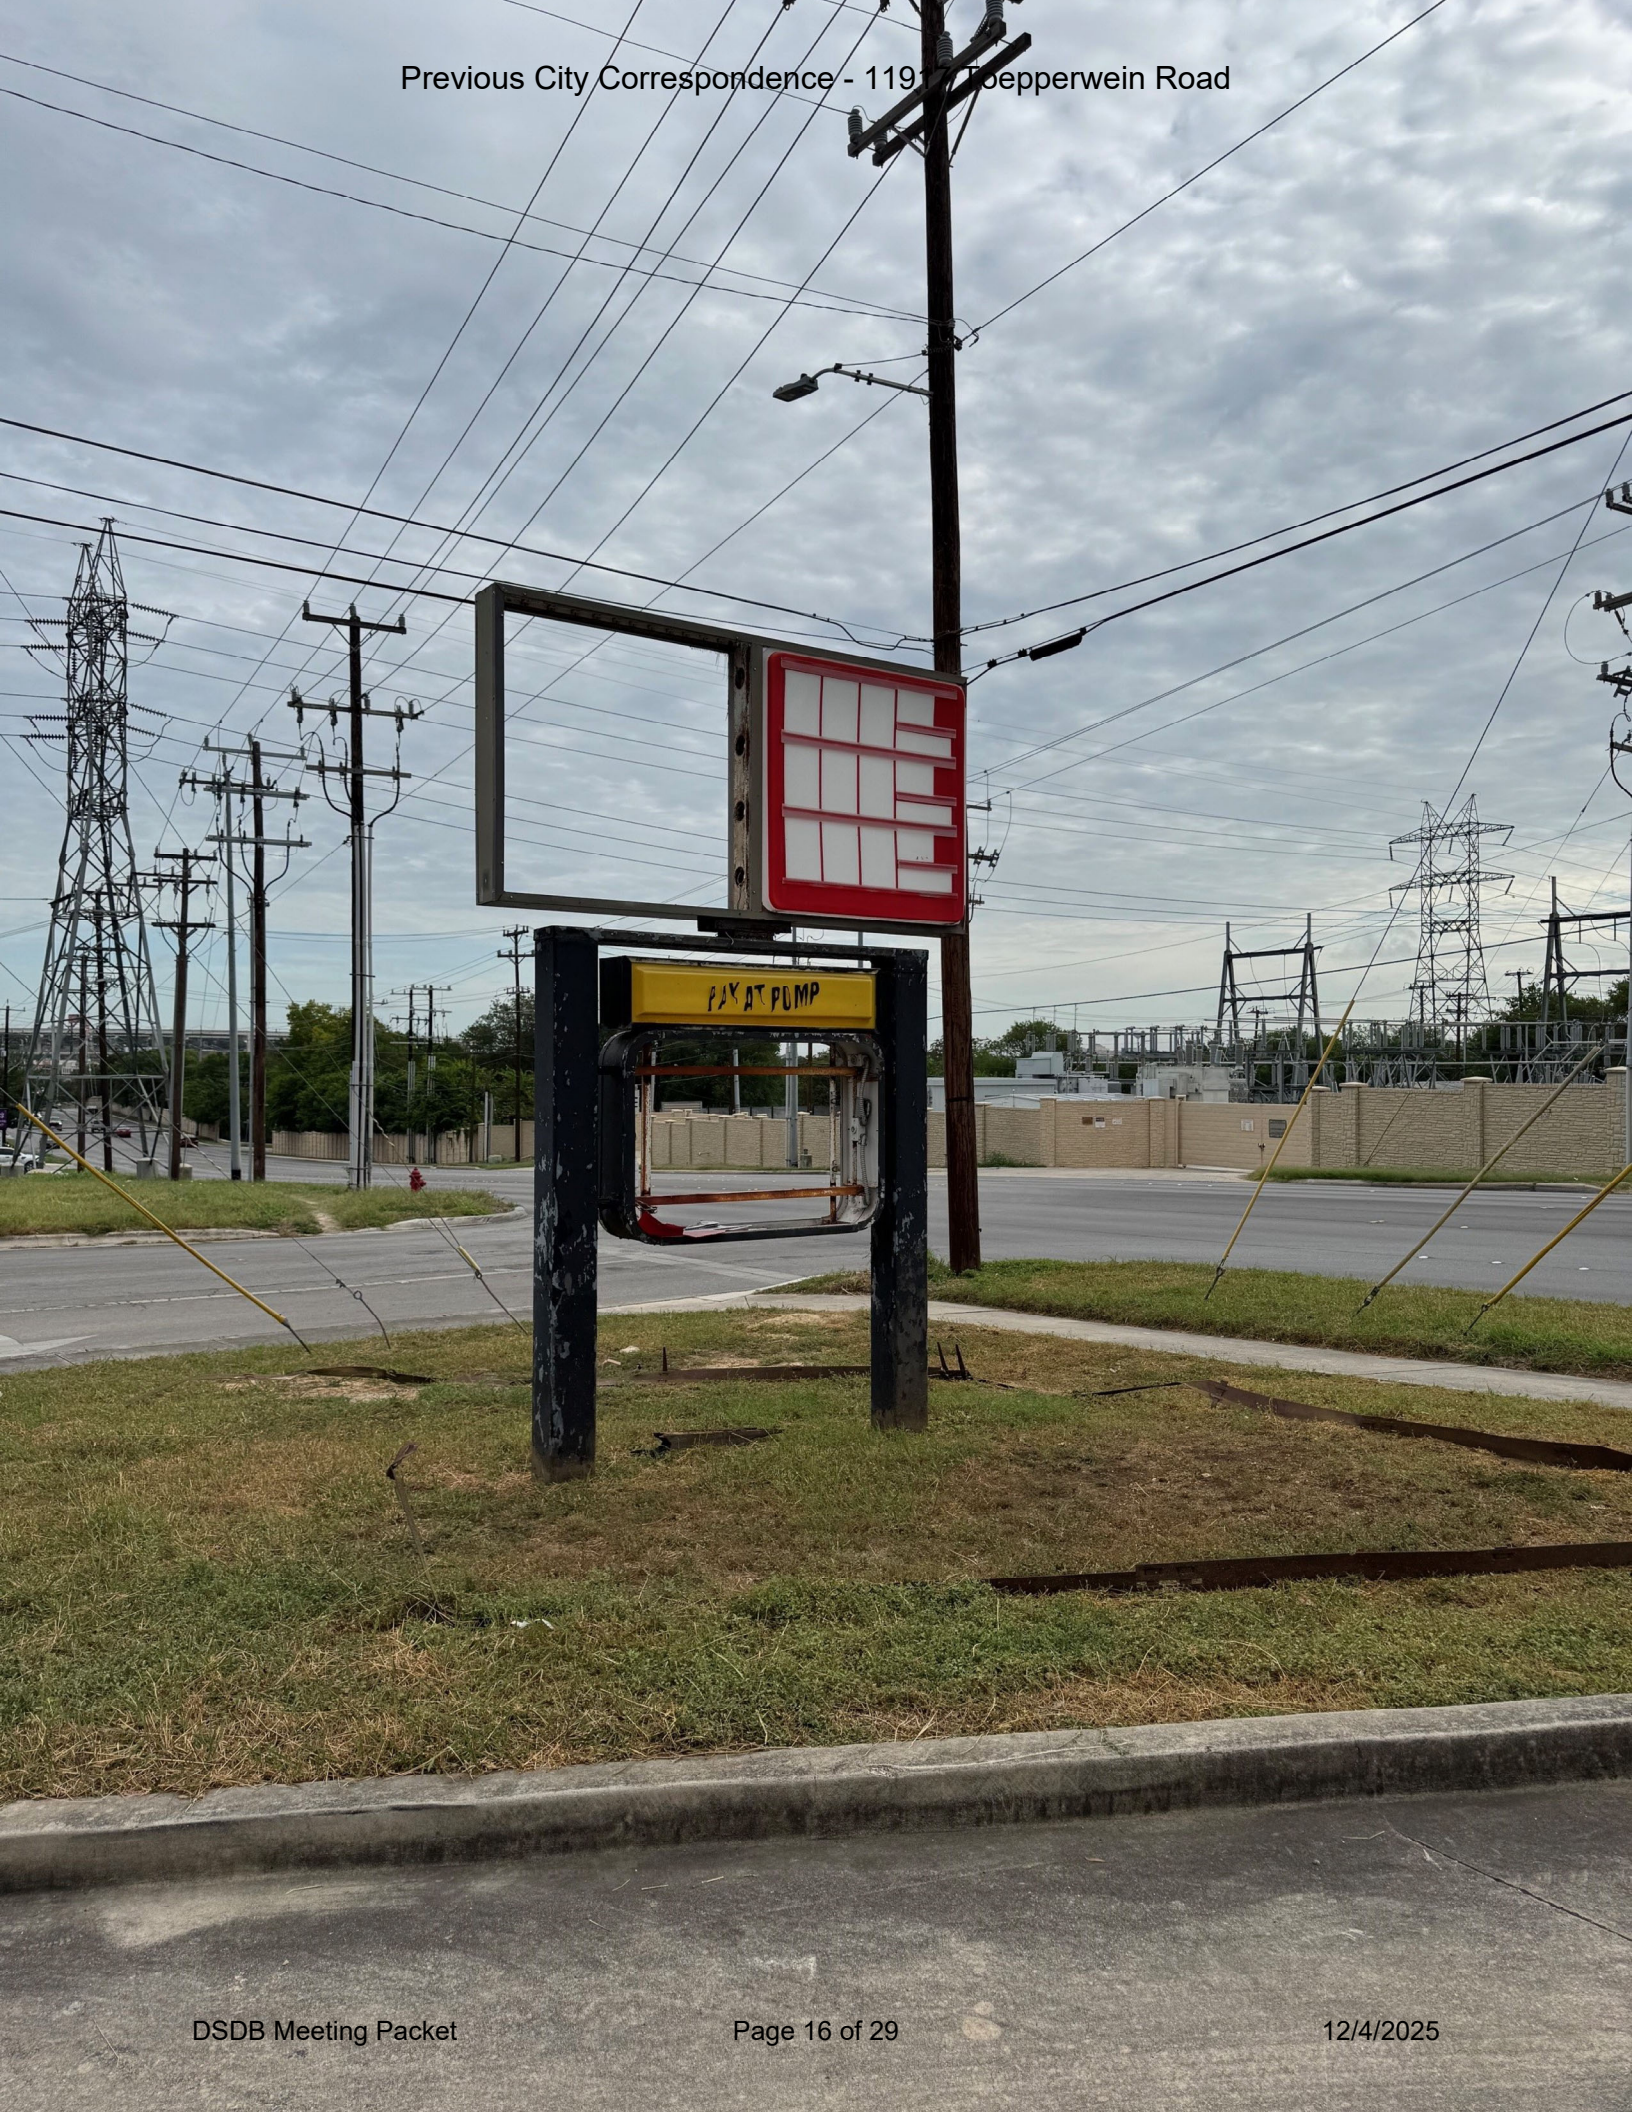
You are hereby notified that the freestanding sign located at the above address on the above-mentioned property has been declared as abandoned per Section 24-85 of the City of Live Oak Code of Ordinances as listed below. The sign, along with the property, has been in a state of abandonment for several years and the sign appears to be damaged and in a state of disrepair per the attached picture taken on July 18, 2025.

*(c) All abandoned and damaged signs and their supports shall be removed within 60 days from the date of abandonment. All damaged signs shall be repaired or removed within 60 days. The appropriate staff official shall have the authority to grant a time extension not exceeding an additional 60 days for an abandoned, nondamaged sign.*

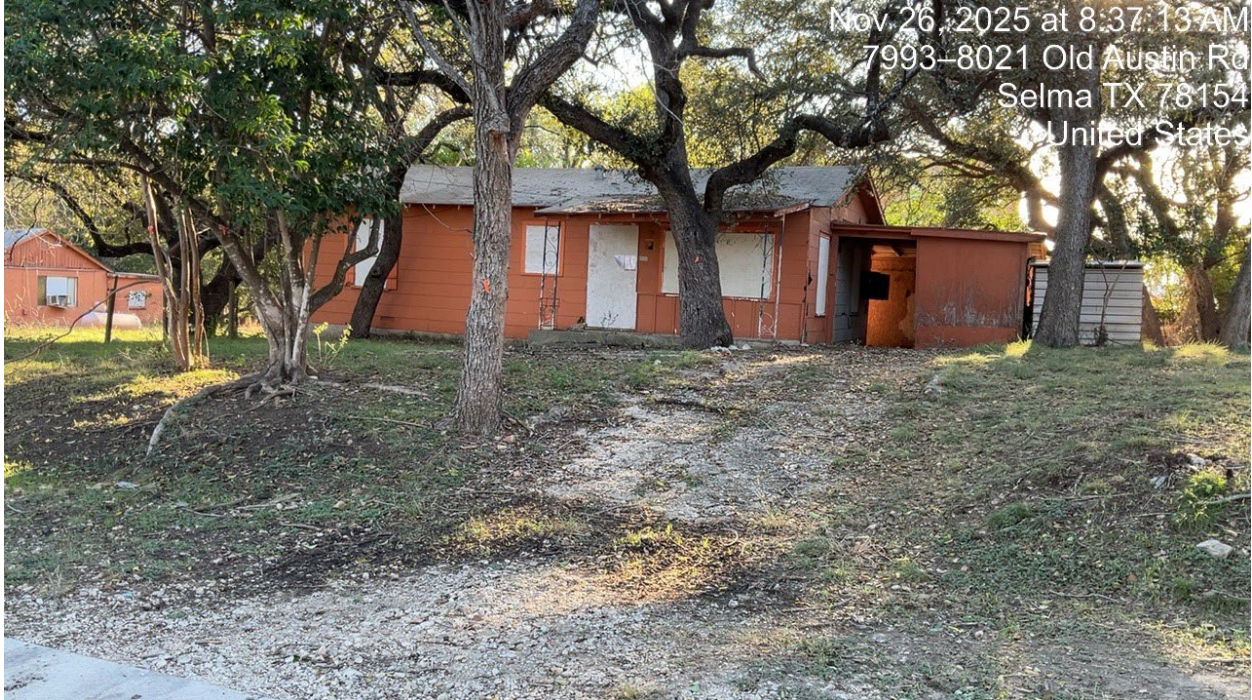
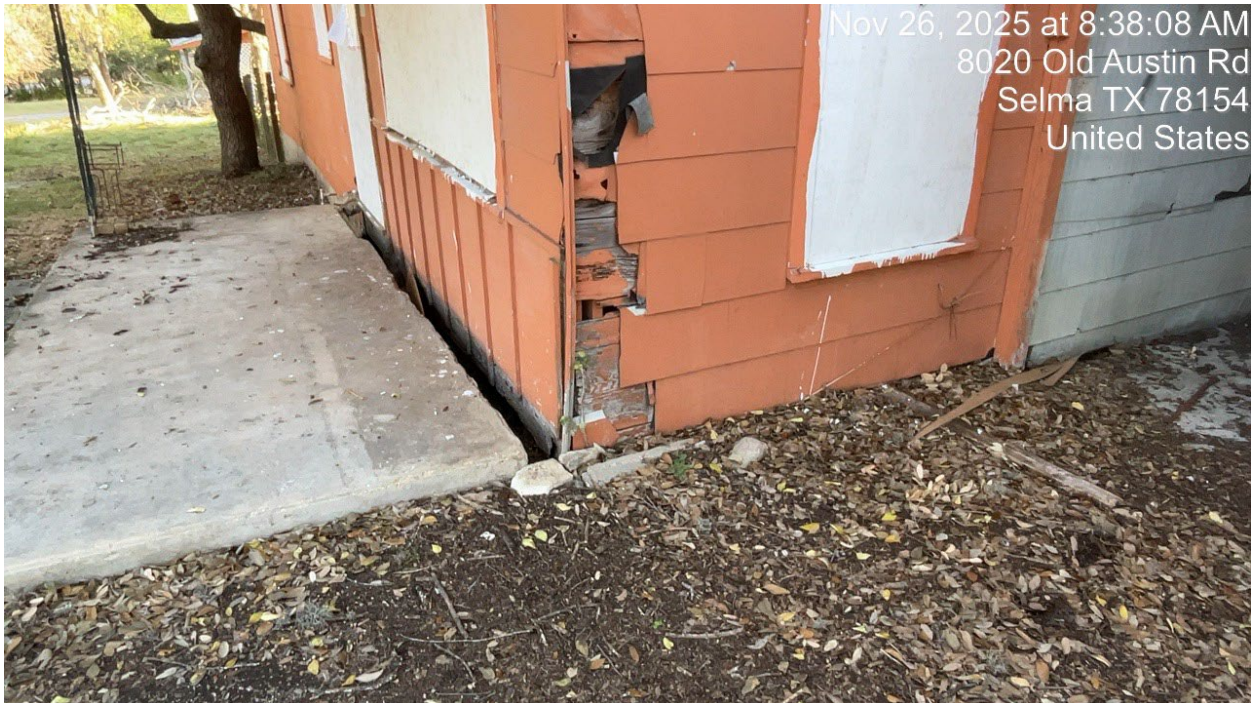
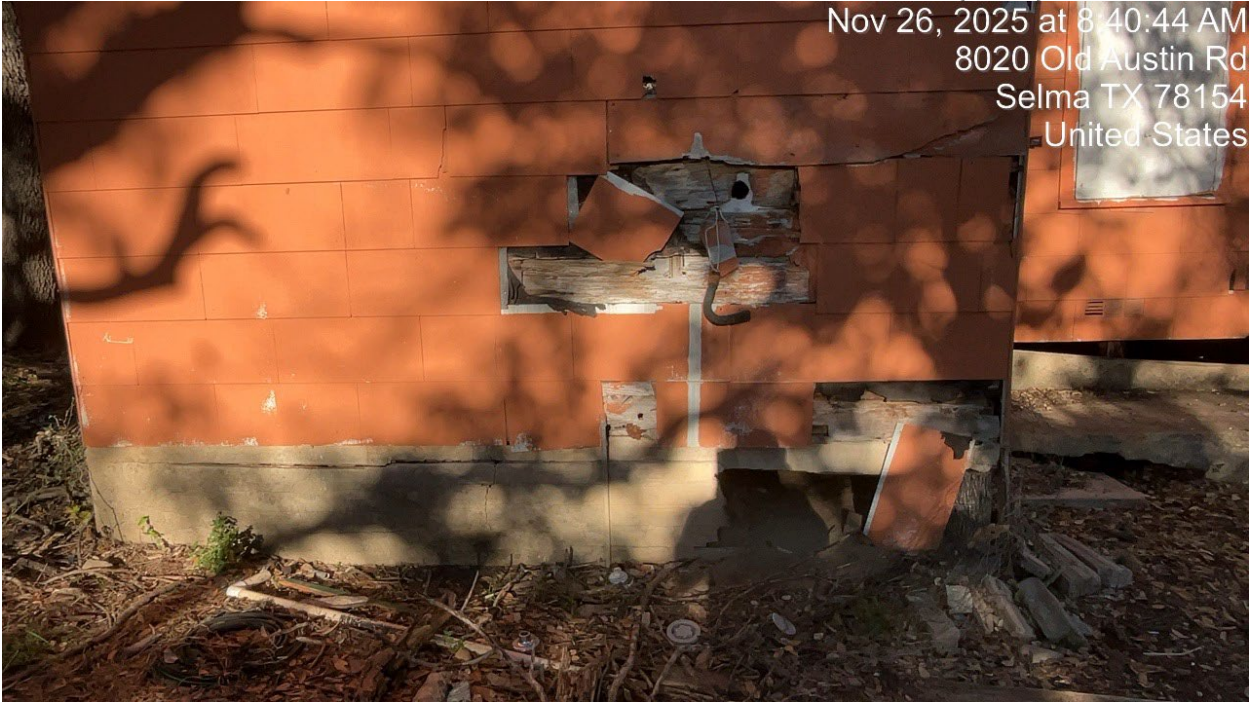
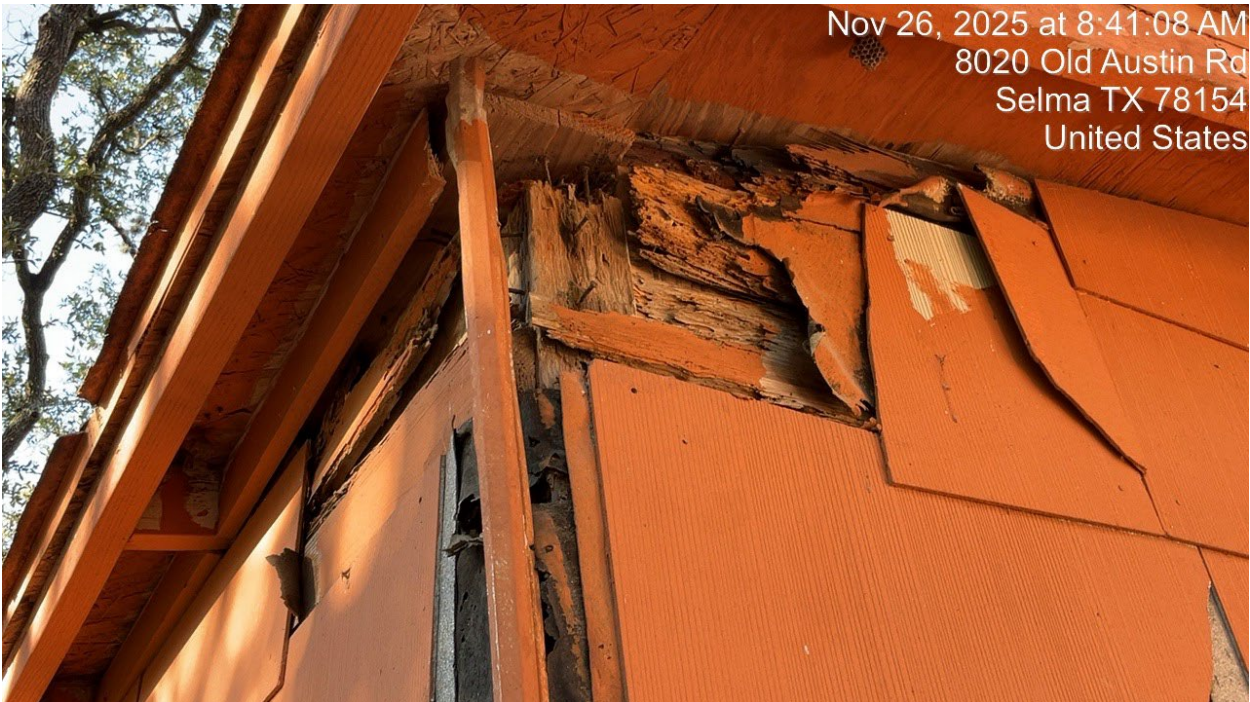
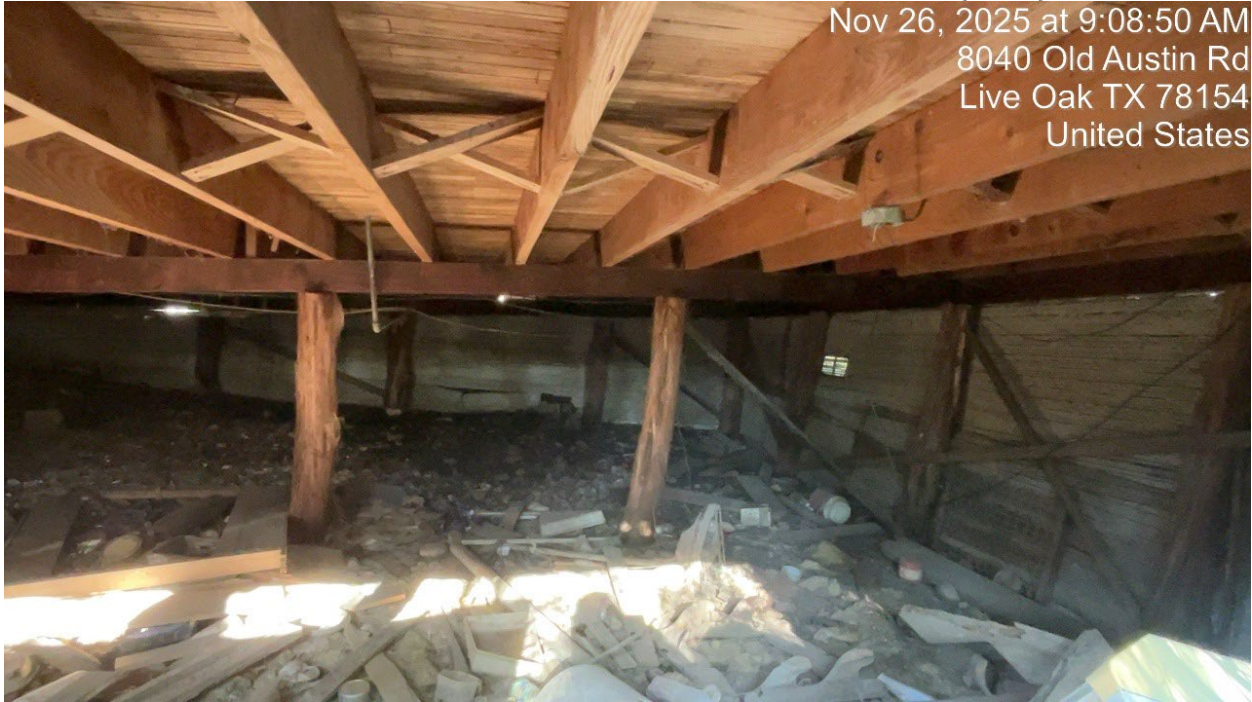
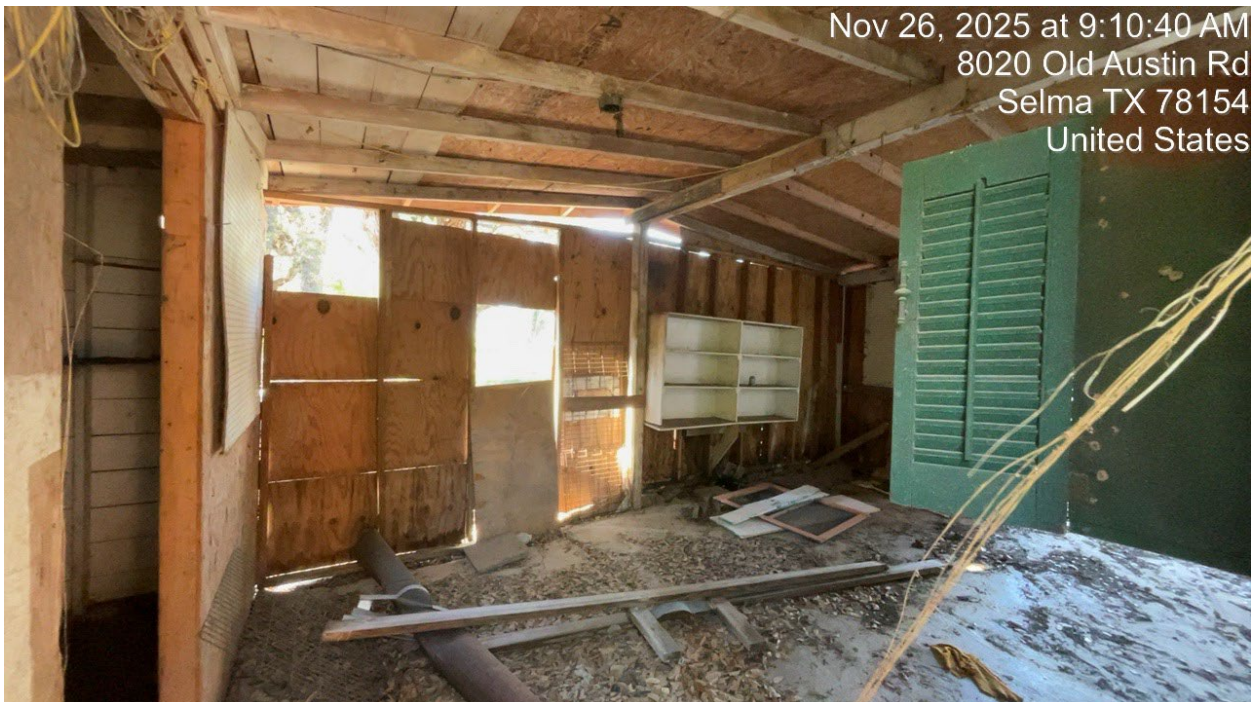
### SITE PICTURES – NOVEMBER 2025 – BUILDING ONE:

The building has significant foundation issues, with the south corner of the building shifting and sinking. There are cracks in the exterior of the building that appear to be from the shifting foundation. The back portion of the structure has cracks in the exterior siding, and the interior living room ceiling appears to have moisture and water damage and is collapsing. The windows and doors on the building have been boarded up and secured by the property owner.

2. The property owner has up to 30 days from the date of the order to provide a detailed scope and schedule to repair structural damages and/or further secure the site and structures as noted herein;

3. The property owner has up to 90 days from the date of the order to begin repairs of structural damages as noted herein, or demolish the buildings and structures;
