AGENDA  
MEETING OF THE DANGEROUS STRUCTURE DETERMINATION BOARD  
CITY OF LIVE OAK  
WILL BE HELD AT THE LIVE OAK COUNCIL CHAMBERS  
8001 SHIN OAK DRIVE  
THURSDAY, DECEMBER 4, 2025 AT 11:00 A.M.

# DANGEROUS STRUCTURE DETERMINATION BOARD AGENDA ITEM FORM

Discussion and consideration regarding 11917 Toepperwein Road (Lot 71, Block 59, Toepperwein Office Park) to determine (1) whether structure(s) meet the definition of a dangerous building to be considered a nuisance; and (2) if the structure(s) are dangerous and therefore a nuisance, what remediation may be required.

City staff has determined that a public nuisance exists and is requesting that the Board make a determination and take action regarding the buildings and structures located at 8020 Old Austin Road. The site contains two abandoned single family detached structures and two small accessory structures. The structure noted as “building one” above has been abandoned since 2021, while the structure noted as “building two” above has been abandoned since

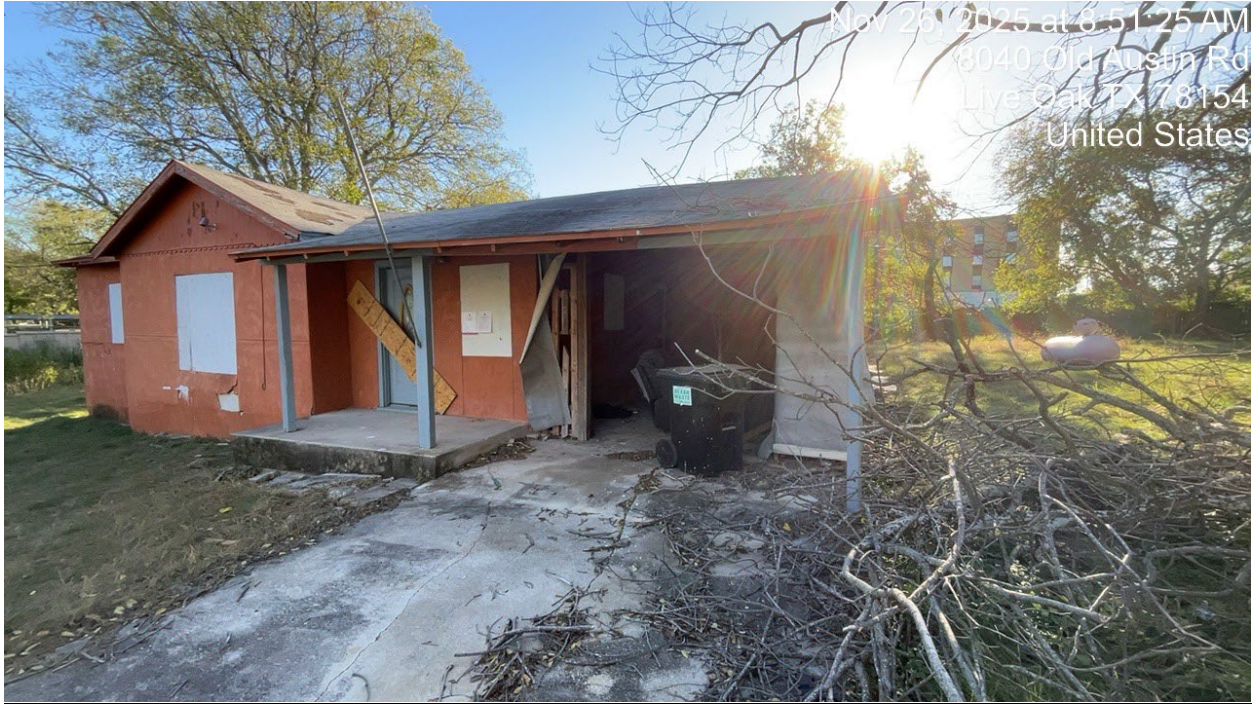
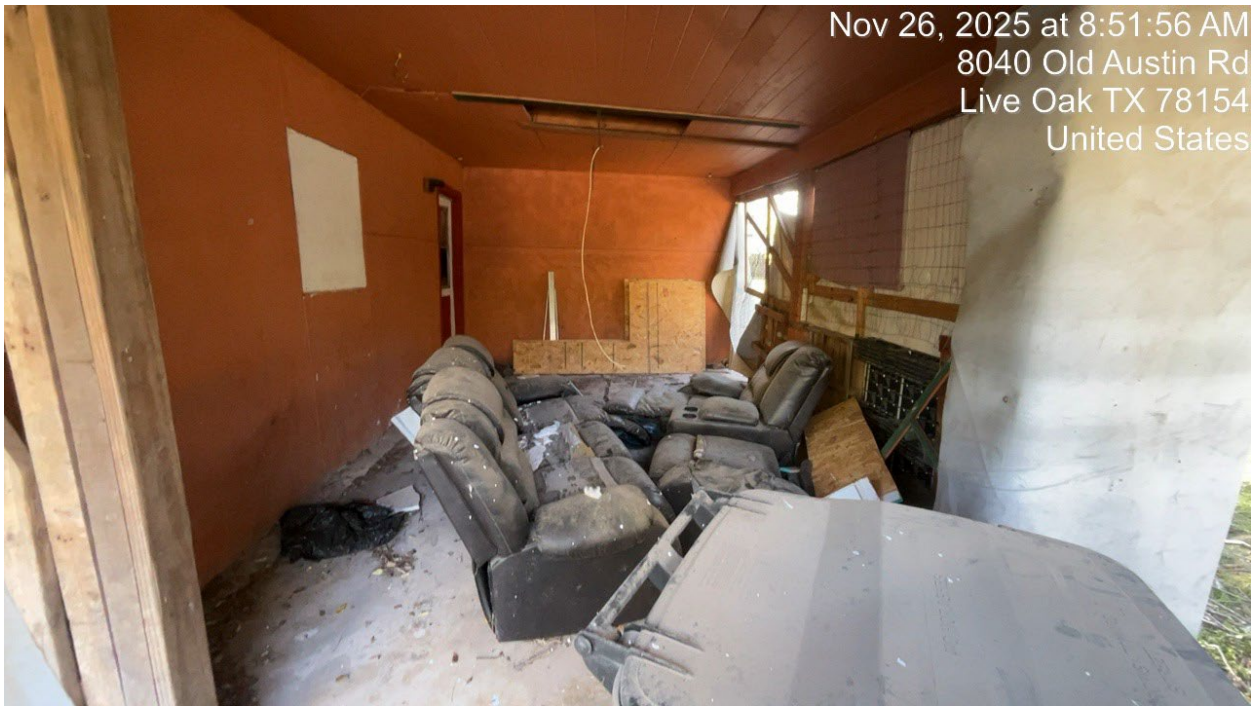
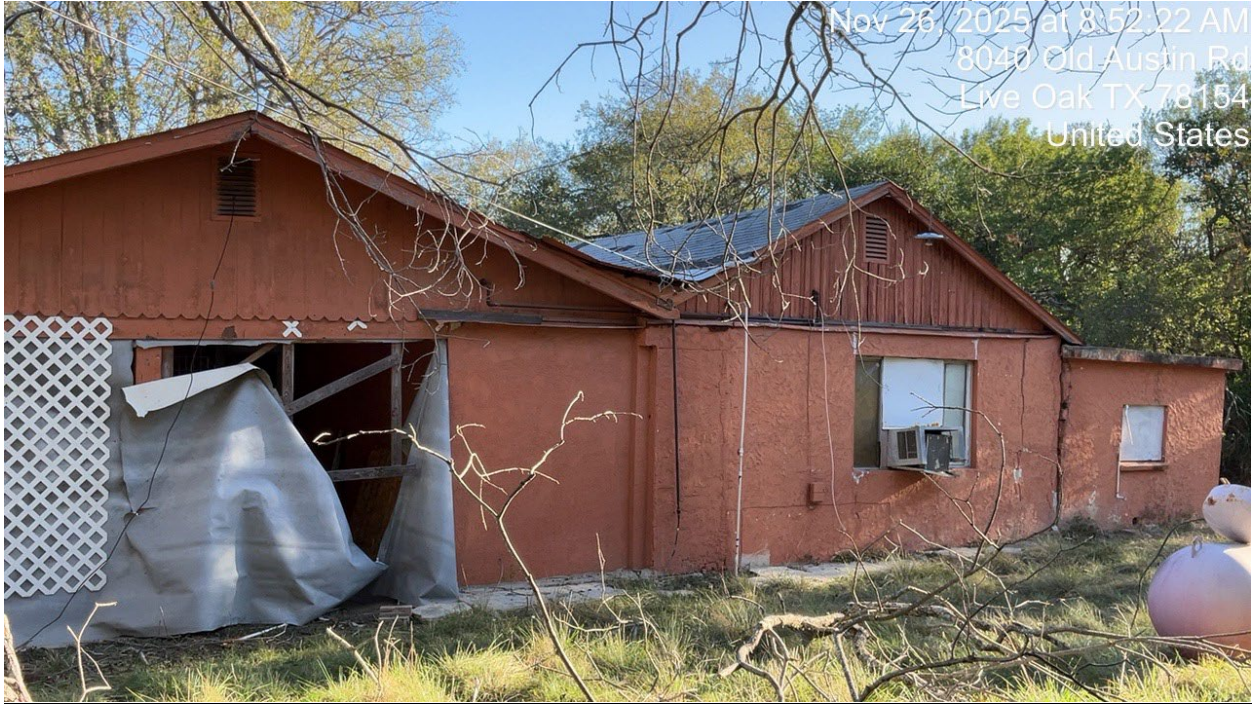
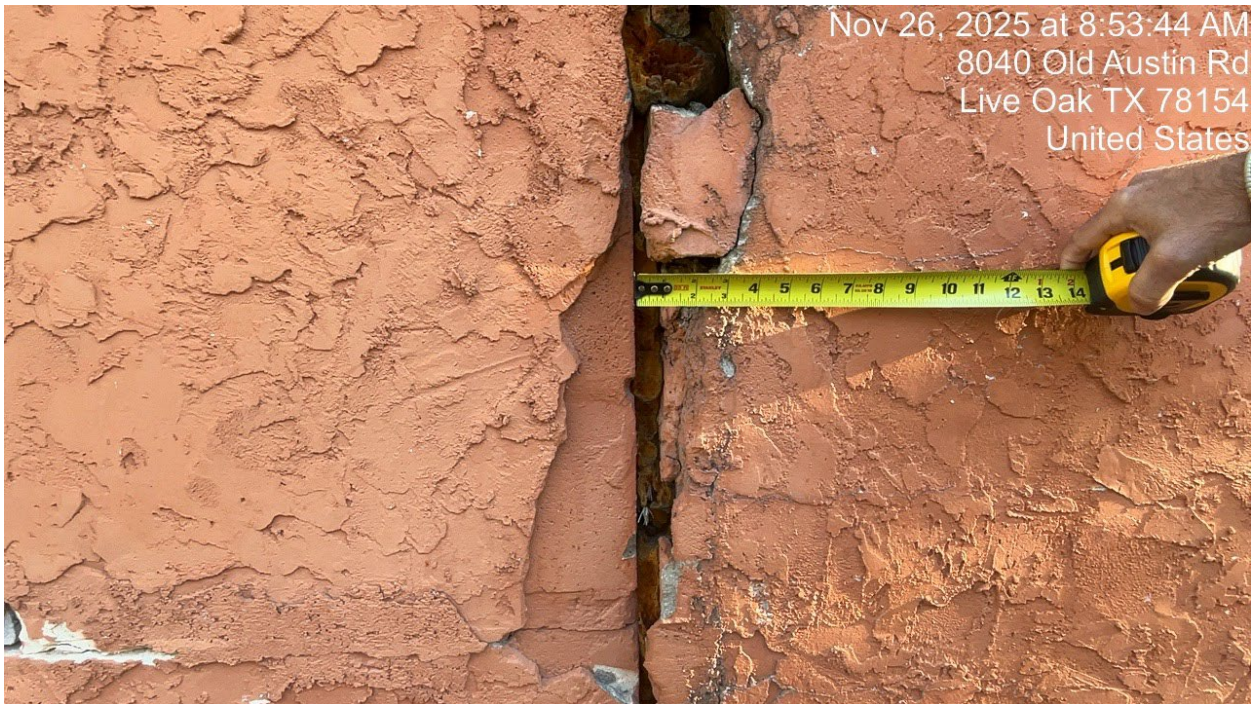
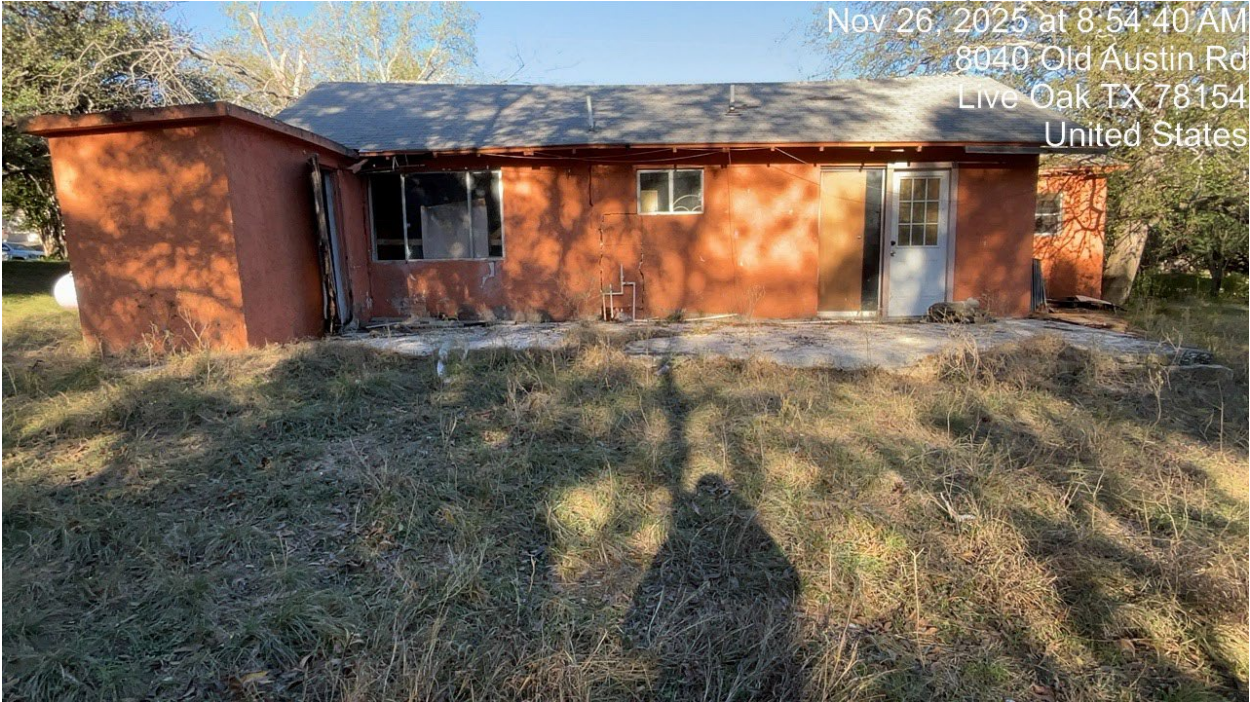
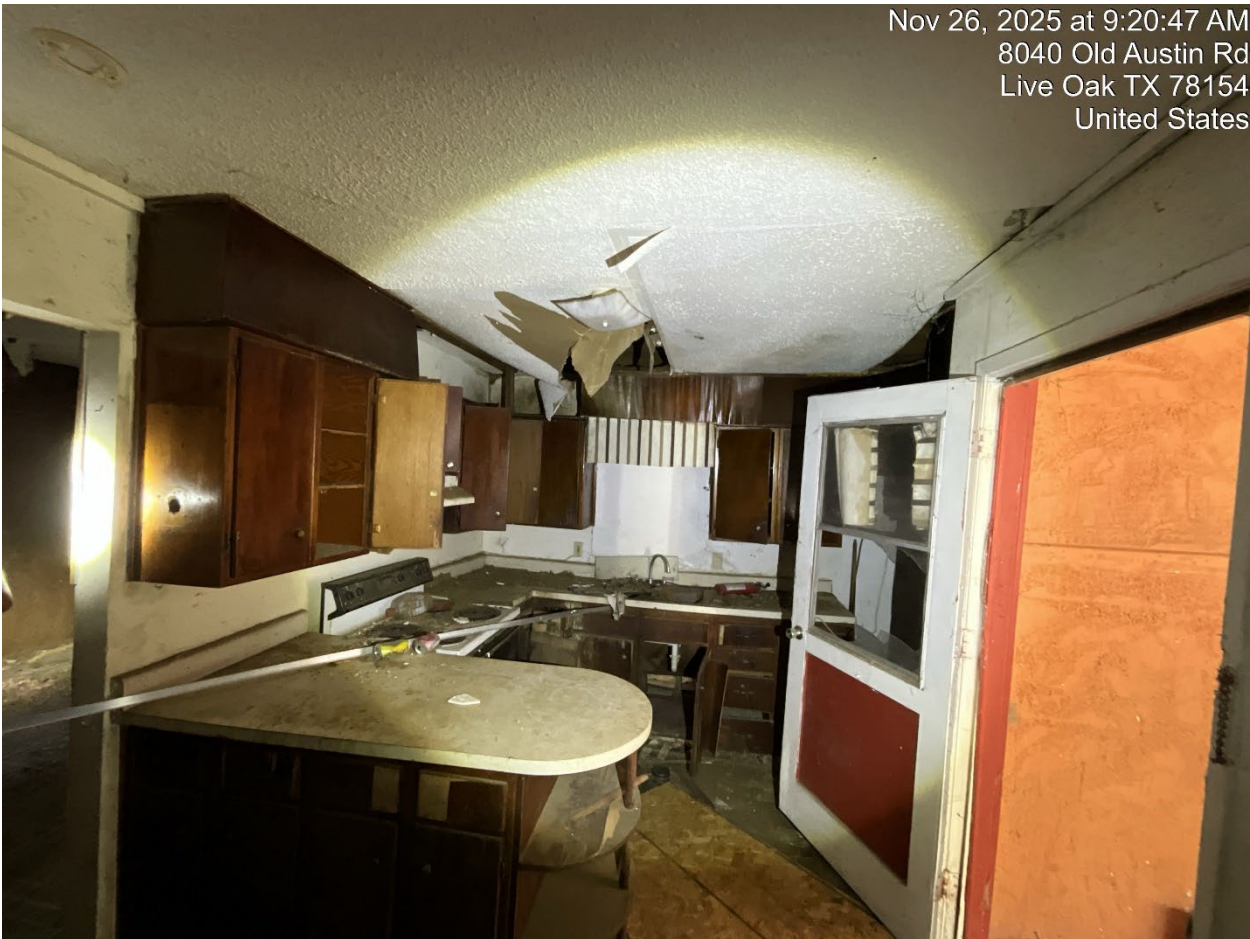
**SITE PICTURES – NOVEMBER 2025 – BUILDING TWO:**

Building two is not secured and has multiple openings. A fallen tree has damaged the south portion of the carport garage. The exterior walls on the garage/carport contains are missing wall panels, with exposed wood that has signs of dry rot and insect damage. There are multiple windows that are unsecured along with an open back door to the southeast of the structure. There is 5-to-6-inch gap from the slab porch to the front of the structure that appears to be from shifting of the foundation. The interior of building two contains multiple ceiling failures, damaged flooring, trash vandalism and signs of vagrant activity.

2. The property owner has up to 30 days from the date of the order to provide a detailed scope and schedule to repair structural damages and/or further secure the site and structures as noted herein;

3. The property owner has up to 90 days from the date of the order to begin repairs of structural damages as noted herein, or demolish the buildings and structures;

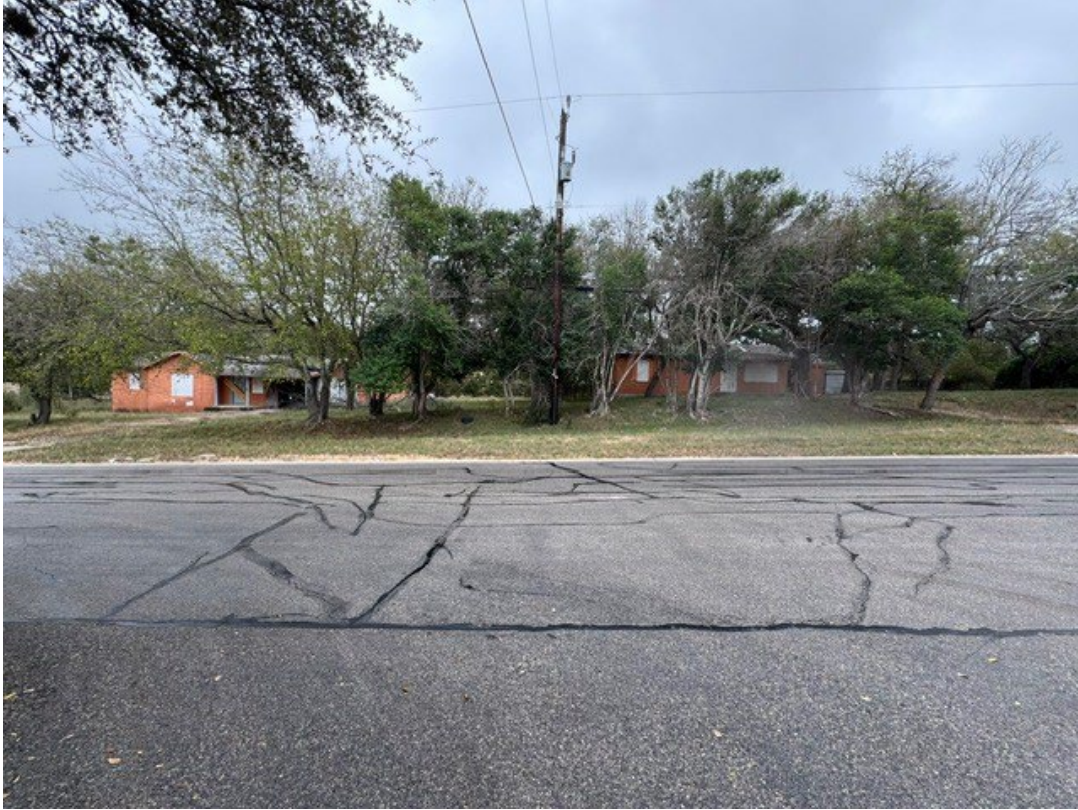
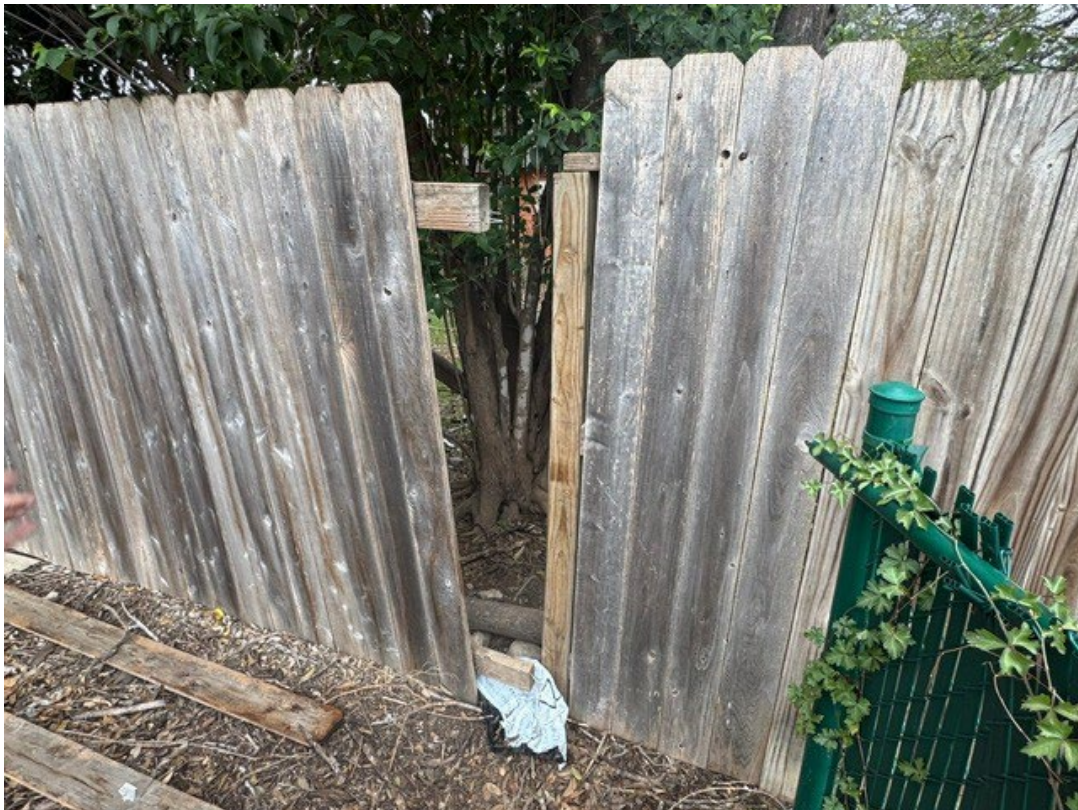
### GENERAL SITE PICTURES – NOVEMBER 2025

The rear fence on the property has missing panels where persons, including potential vagrants, have entered and exited the property from the parking lot of the commercial properties to the southeast.
